ARKDALE LAKE MANAGEMENT PLAN

APPROVED 5/09 BY WDNR

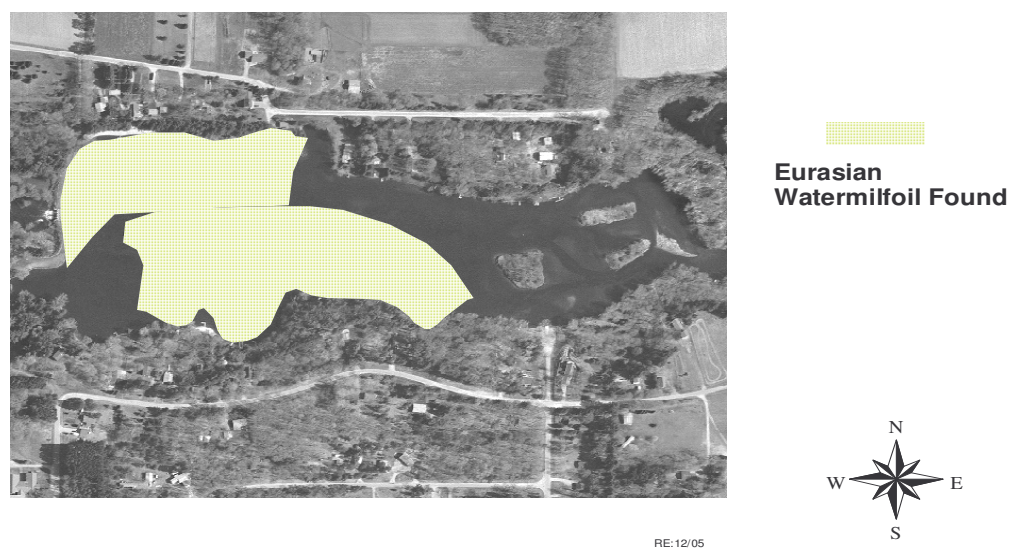
Figure 13d: Distribution of Eurasian Watermilfoil in Arkdale Lake in 2005

An aquatic plant survey of Arkdale Lake was done in 2005 by Adams County LWCD staff. 16 species were found. This included four emergent species, three free-floating plants, one floating-leaf rooted plans and eight submergent species. One invasive exotic, *Myriophyllum spicatum* (Eurasian watermilfoil), was found at several sites in the lake, with an occurrence frequency of 35.7%. A second invasive exotic, *Potamogeton crispus* (curly-leaf pondweed), was also found, but was infrequently-occurring.
